**Residential Development, Boherboy, Saggart, Co.
Dublin**

Report on Site-Specific Flood Risk Assessment

Kelland Homes Ltd. / Evara Developments Ltd.	Document Ref. No.	Kilgallen & Partners Consulting Engineers Well Road, Portlaoise Co. Laois
	24023-R-SSFRA Issue PL4

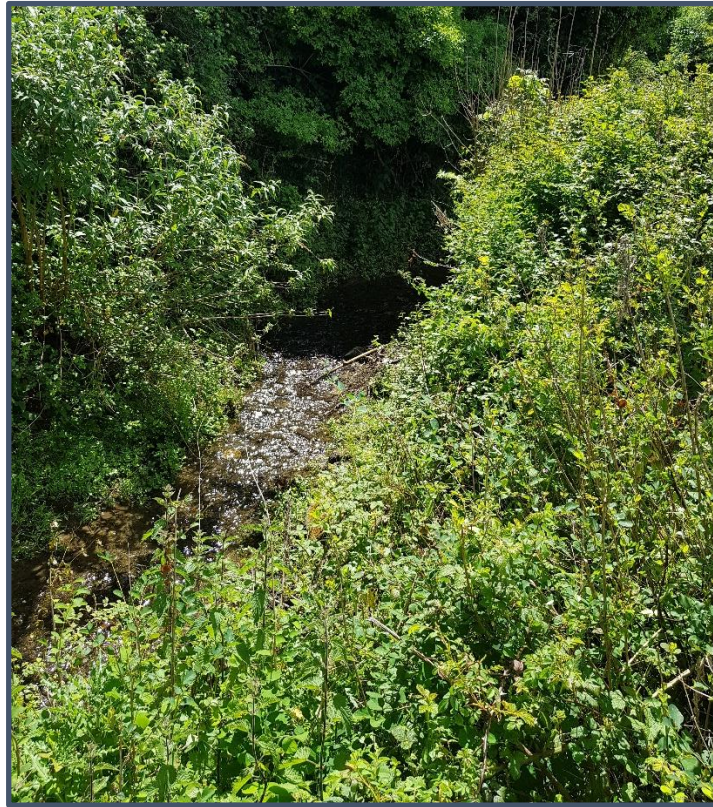
Figure 4-5 Stream at eastern boundary

The Corbally stream enters the Site at its southeast boundary via a culvert under the Boherboy Road. This stream flows along the eastern boundary of the Site until it meets the northern boundary, whereupon it turns towards the west and flows along the northern boundary before discharging to a culvert at the northwest corner of the Site. The outfall culvert comprises 4no. 450mm dia. pipes.

As expected, the Corbally Stream follows the Site topography and its gradient is steep, particularly so along the eastern boundary.

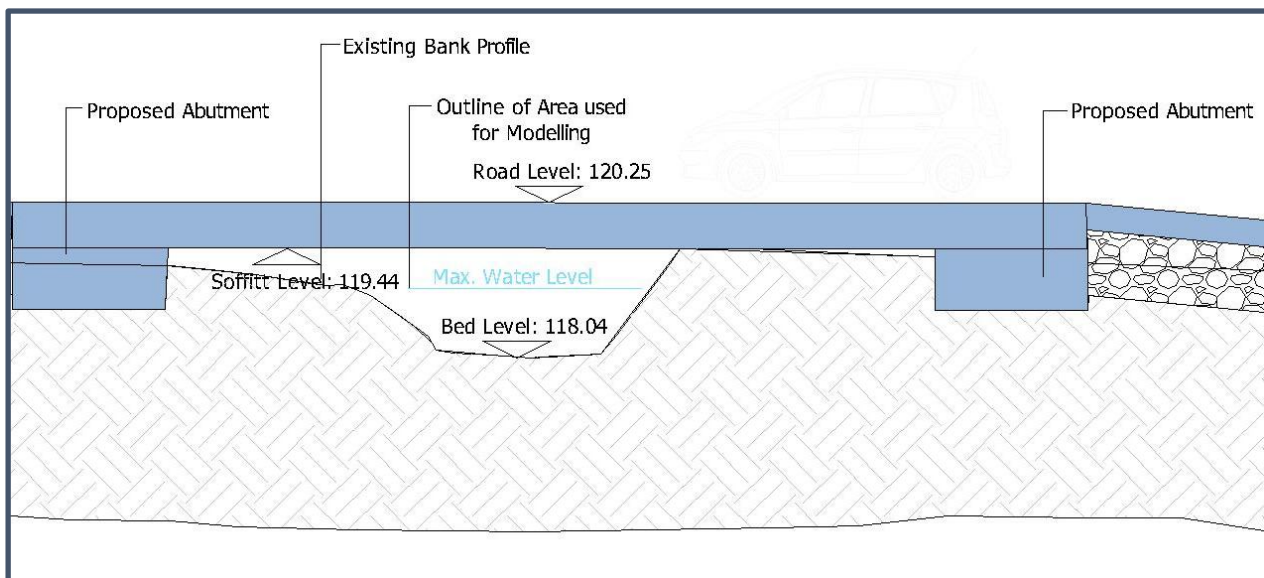
**Figure 5.8 Typical Section at Stream Crossing (Carrigmore)**

Figure 5.8 shows a typical section at a stream crossing.

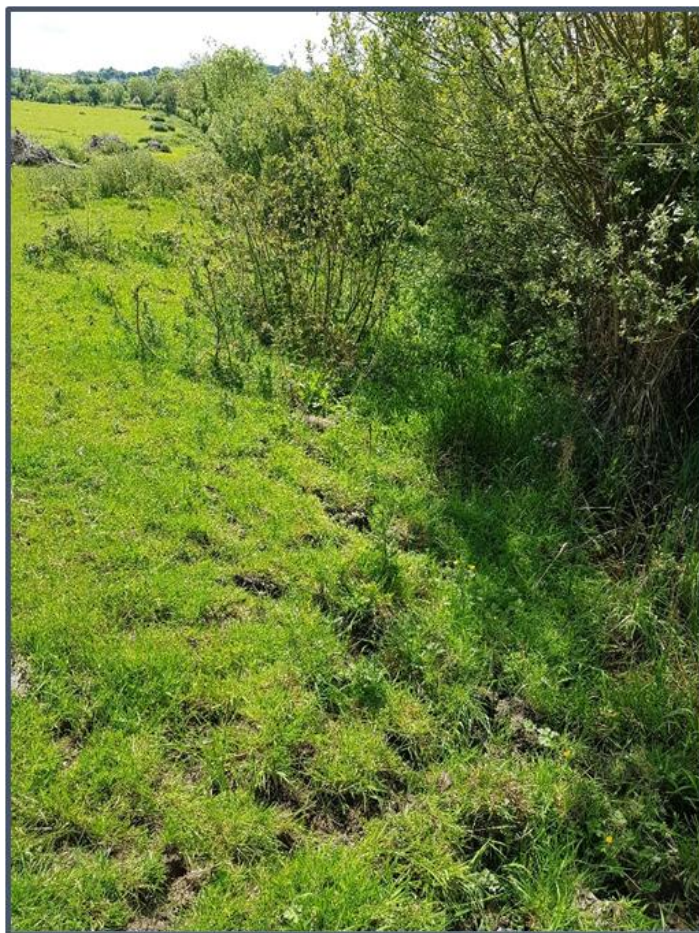
Figure 7.1 Local field ditch drain through centre of Site

The Site comprises two rectangular fields in parallel stretching from the southern boundary to the northern boundary, both under agricultural use. The boundary between the fields is defined by a hedgerow and local field ditch (EPA Designation Code 09C60); this ditch starts inside the Site, close to the south boundary, and outfalls to the Corbally Stream at the north boundary. A similar local field ditch (EPA Designation Code 09C62) adjoins the western boundary of the Site; this ditch starts at the south boundary and also discharges to the Corbally Stream.

Both ditches are to remain open post-development. The ditch at the west boundary will remain largely unchanged; the ditch through the middle of the Site will become a swale with a filter drain installed below its bed (Ref RMA Dwg 1324D-416). The drainage paths established by these field ditches will therefore be preserved post-development.
